Assessment of Dam Safety

Coal Combustion Surface Impoundments (Task 3)

PacifiCorp

Naughton Power Station

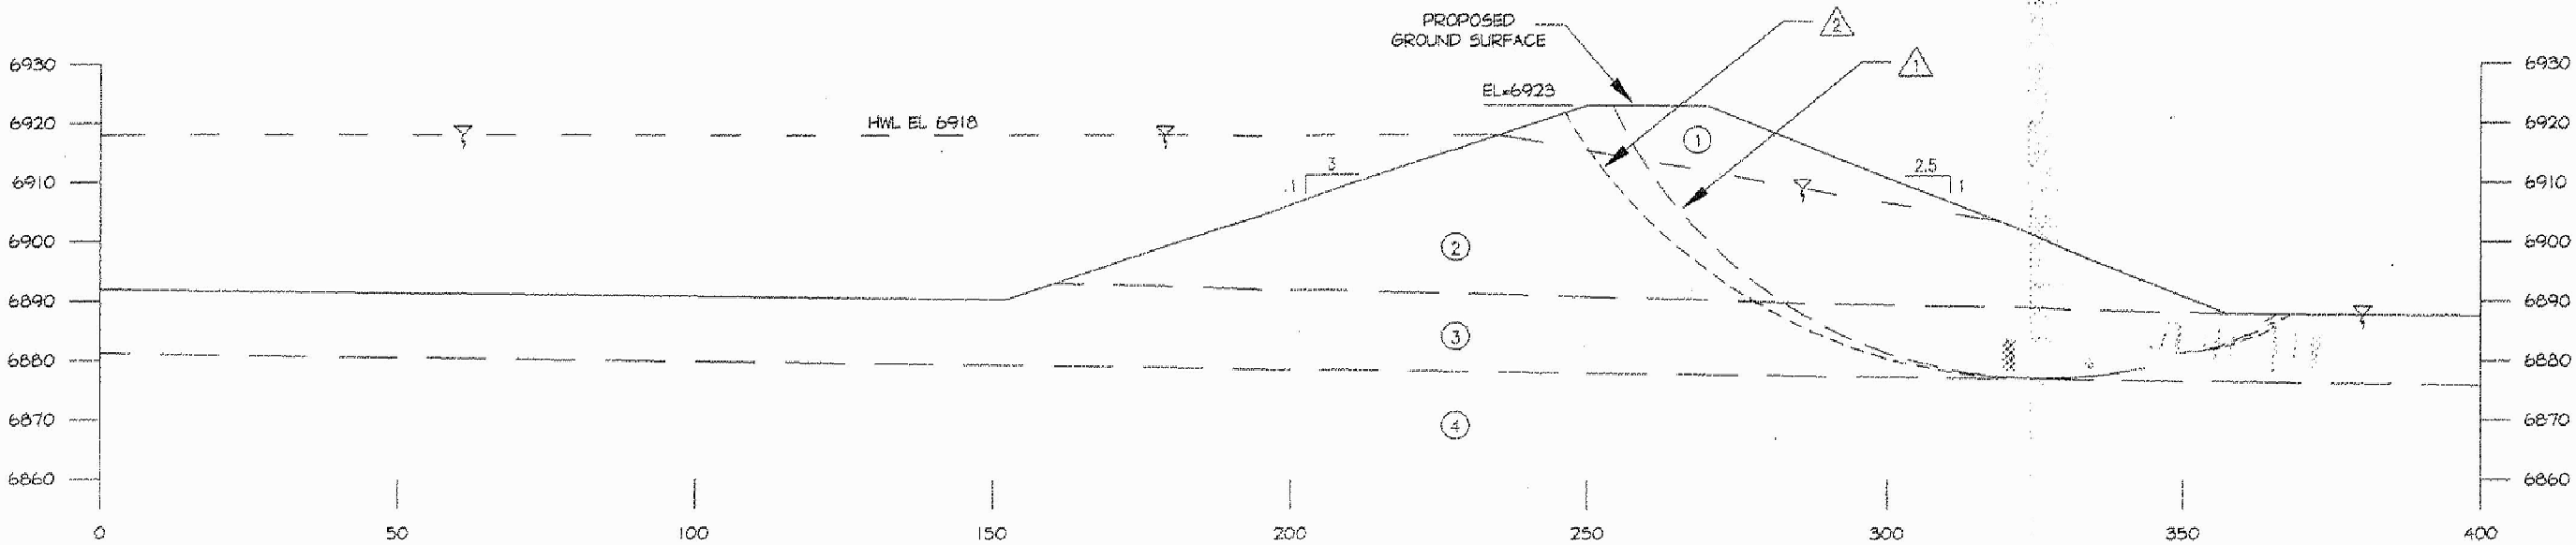
PROJECT NO.
20085.2020
DATE: 10/2009
FIGURE 5B

SOIL LAYER	WET UNIT WEIGHT (pcf)	COHESION (psf)	FRICTION ANGLE (°)
① FILL ABOVE GWL	122.0	600	26
② FILL BELOW GWL	122.0	600	26
③ LEAN CLAY	119.5	200	25
④ CLAYSTONE BEDROCK	130.2	4000	0

CASE		①	②
CONDITIONS		STATIC	PSEUDO- STATIC
MINIMUM FACTOR OF SAFETY		1.5	1.1
REQUIRED FACTOR OF SAFETY		1.5	1.0
RADIUS		79 ft	92 ft
CENTER	HOR. POINT	326	325
	VERT. POINT	6956	6969
SEISMIC COEFFICIENT		0.00 g	0.10 g

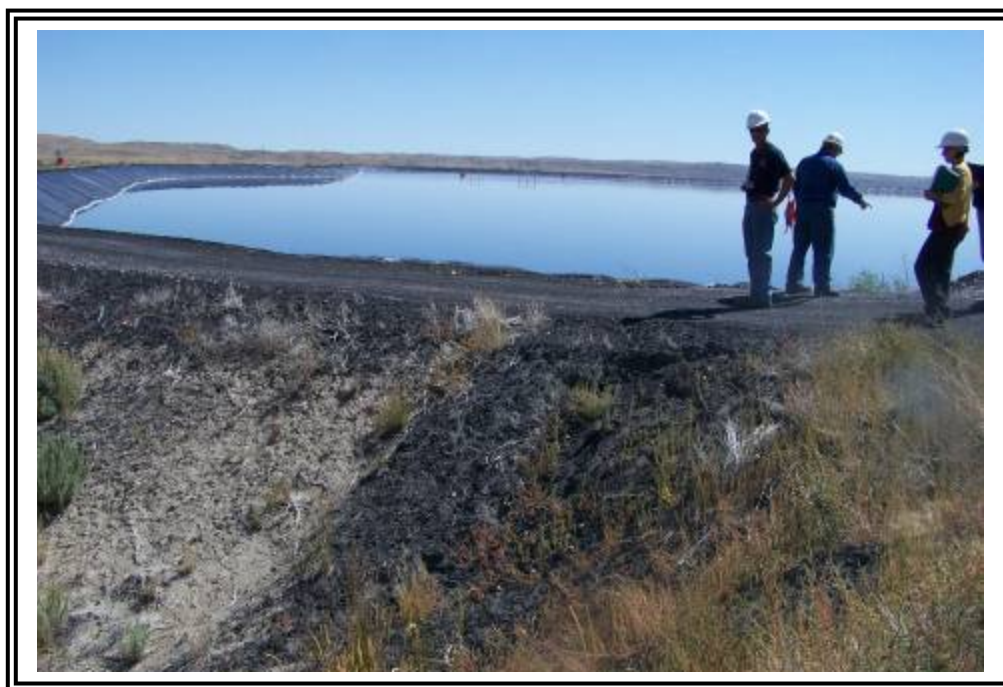
5

Erosion rivulet at north end of northeast dike adjacent to access road ramp to toe of dike.

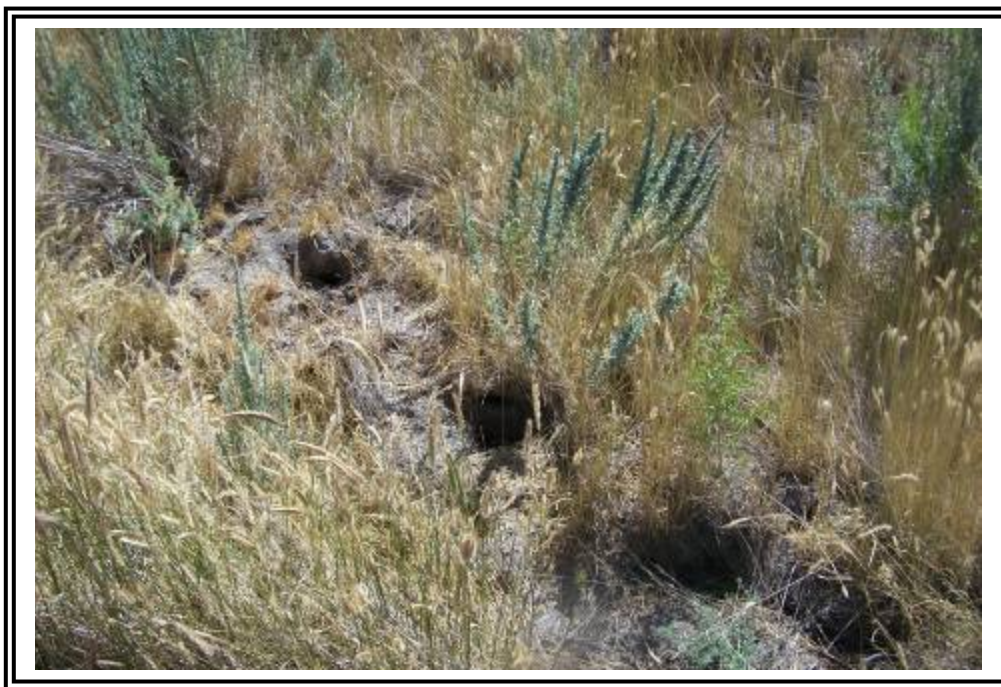
9

Animal burrows along toe of northeast dike (northern end of dike).

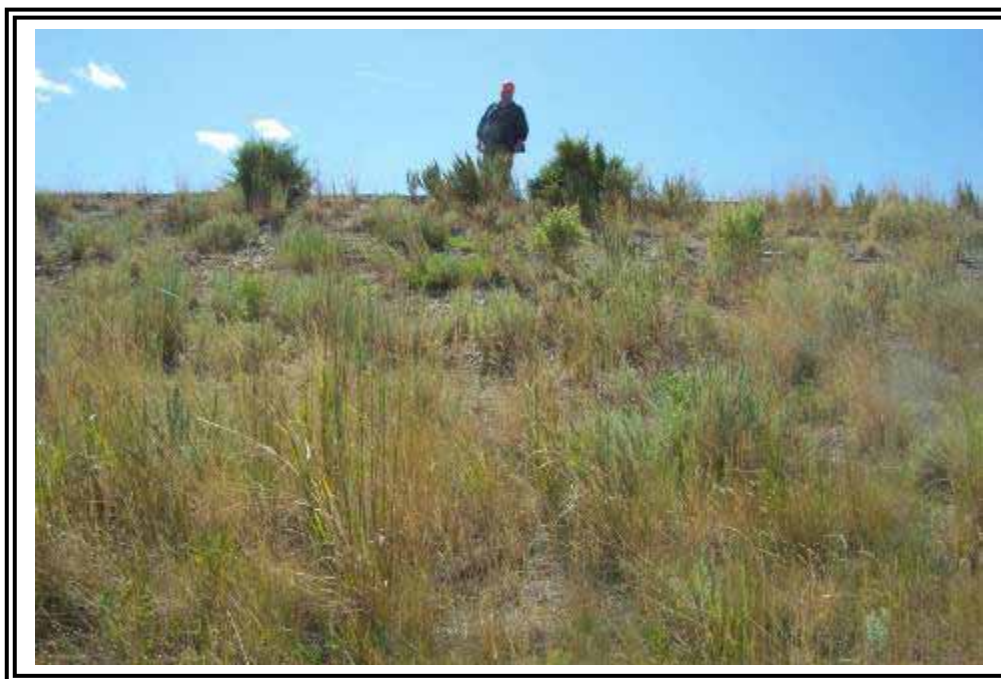
Near the mid point of the northeast dike, a crack, about 65 feet long was observed about 12 feet below the crest elevation. This crack was generally parallel to the slope and could be penetrated with a rebar probe up to about 2 feet in some areas. Photos 10 and 11 show the area and appearance of this crack.

Slope erosion rivulets and irregular surface on downstream slope at about mid point of northeast dike (area of crack).

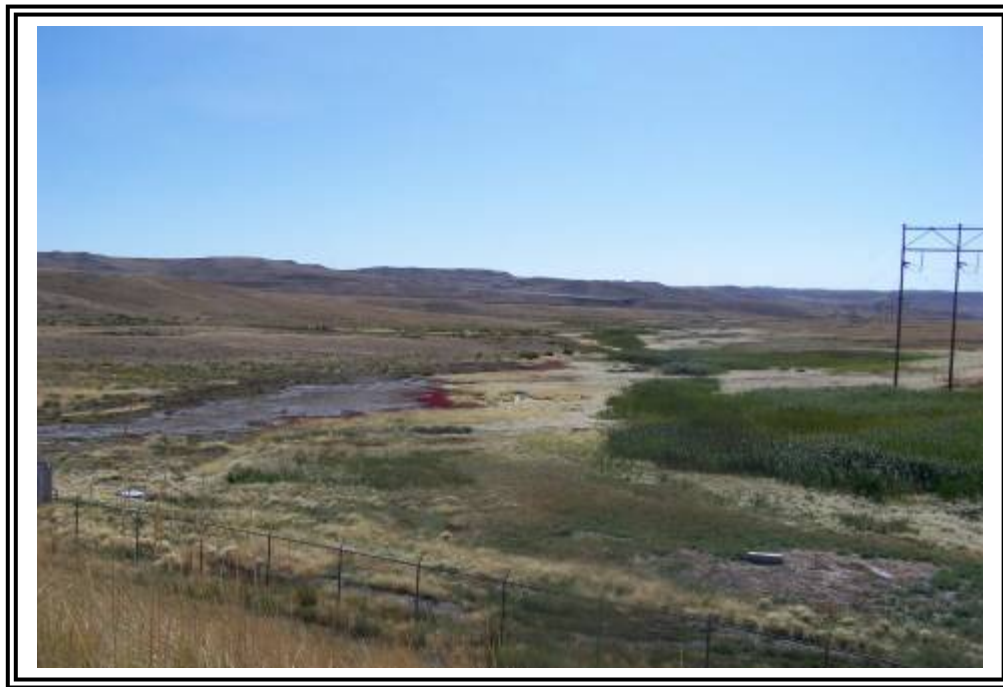
37

chemistry. The leak was hypothesized to be below the FGD byproducts and therefore, deemed impractical to repair. To contain this seepage on site, a cutoff/seepage collection trench of crushed stone lined on the downstream side with a geomembrane was installed. Seepage water is collected in this trench and then pumped back to the FGD #2 Pond. PacifiCorp expects compressing/settling FGD byproducts to have a decreasing permeability and personnel accompanying CHA in the field indicated a reduction in pump back volume has occurred since the installation of the system. The area of the pump back system and original seepage is seen in Photo 37.

Downstream toe area at south corner. Area of seepage pump back system.

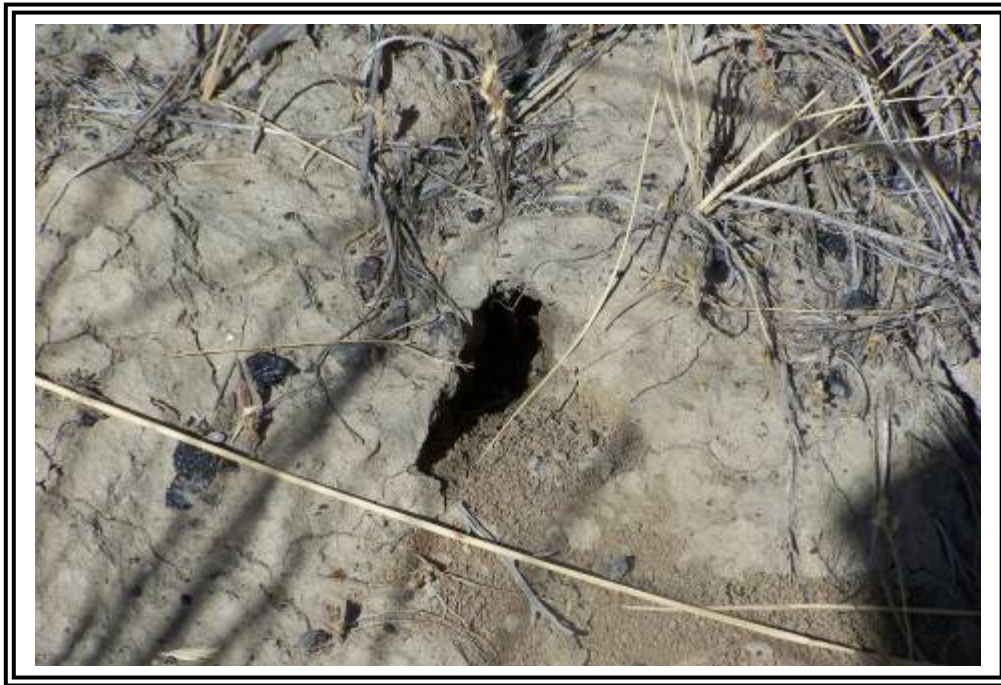
41

Animal burrow on east dike.

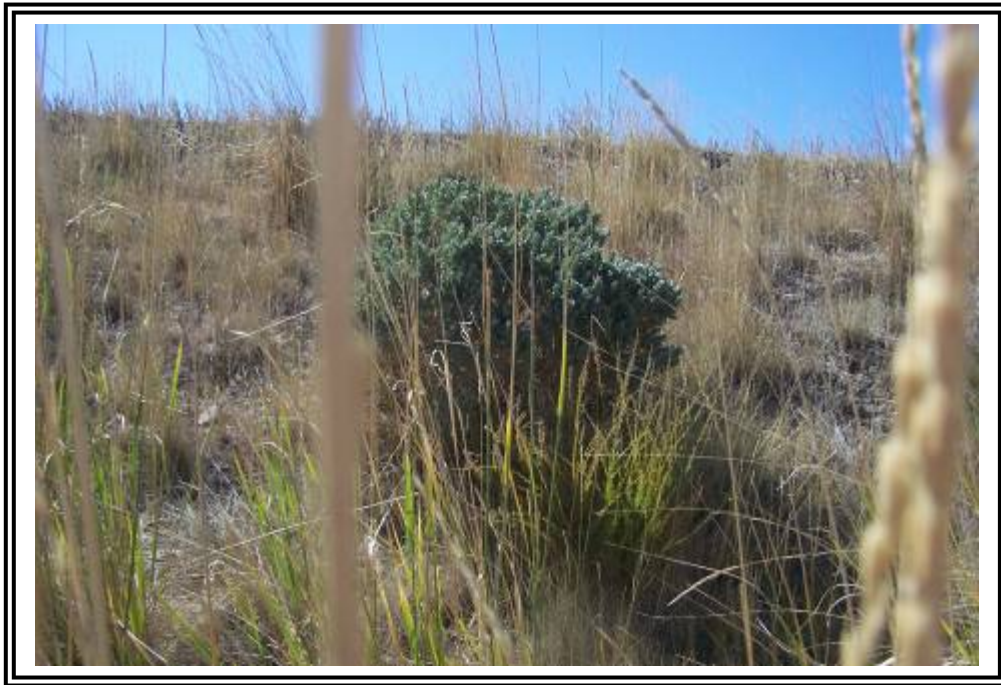
43

The downstream slopes are vegetated primarily with crested wheatgrass, although occasional sage bushes (Photo 43) are present. Photos 34, 40, and 42 show the general conditions of the vegetation. As these photos show, the vegetation is very sparse in some areas, with apparent growth hampered by prevailing direction the slopes face. Occasional erosion rills were noted, such as that shown in Photo 18. Numerous animal burrows were observed along the downstream slopes. Photos 41, 42, 44, and 46 show the ranges of sizes of these animal burrows. In general the slopes appear fairly uniform, and did not exhibit signs of movement.

Sage shrub on east dike.

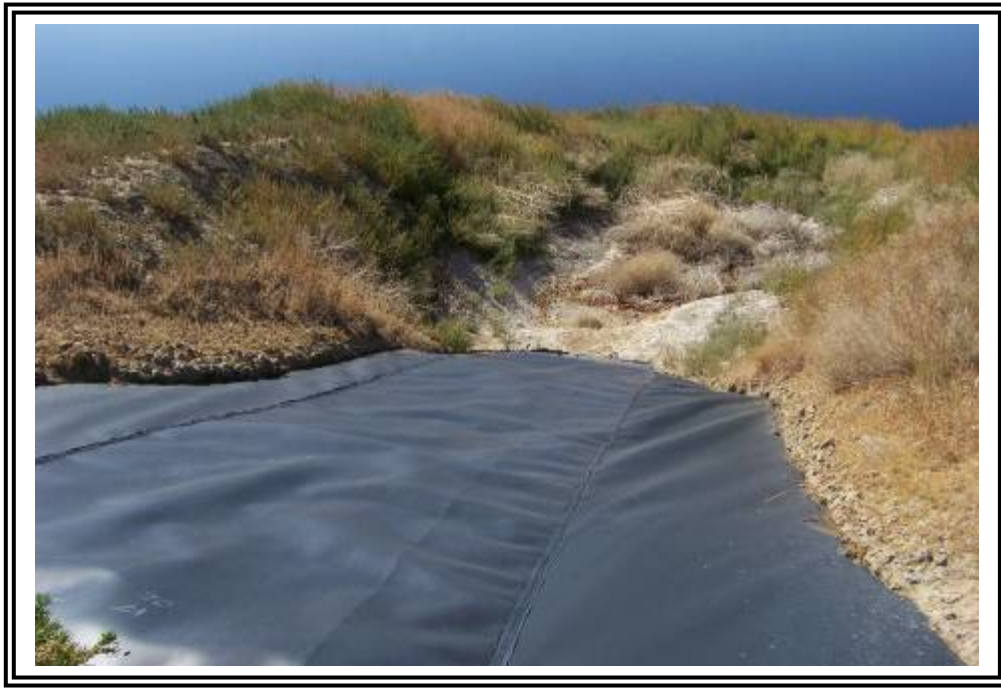
49

Patch along seam in upstream liner along north dike. Soil on top of liner remnant of coffer dam built for repair.

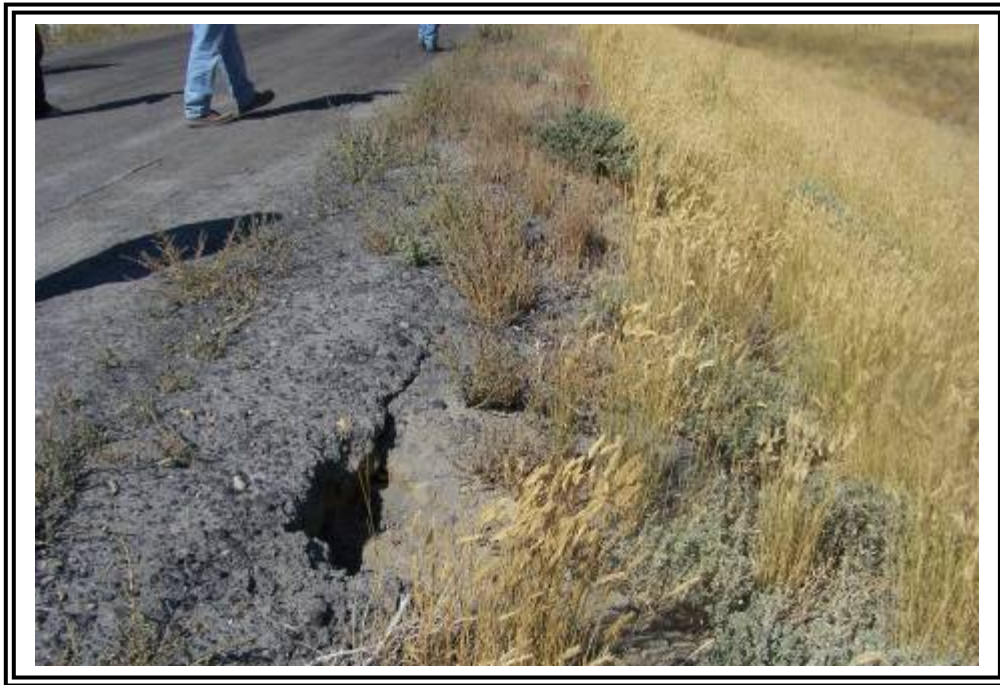
65

Animal burrows were observed in several locations on the downstream slope of the intermediate dike such as shown in Photos 58 and 68. Near the northeast corner of the Intermediate Dike, a crack was observed adjacent to an animal burrow as shown in Photo 65. The crack appeared to be related to the grading of the access road material.

Cracking and animal burrow or sinkhole on Intermediate Dike. Appears to be related to access road material.

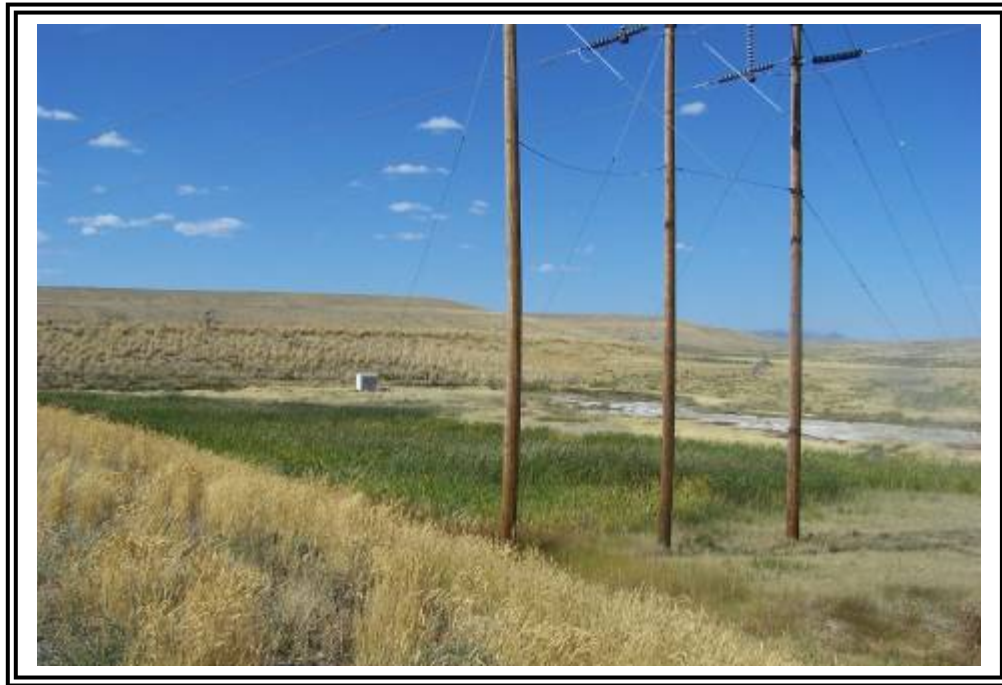
67

Possible seepage area at north end of Intermediate Dike. Adjacent but downstream of FGD #2 pump back area.

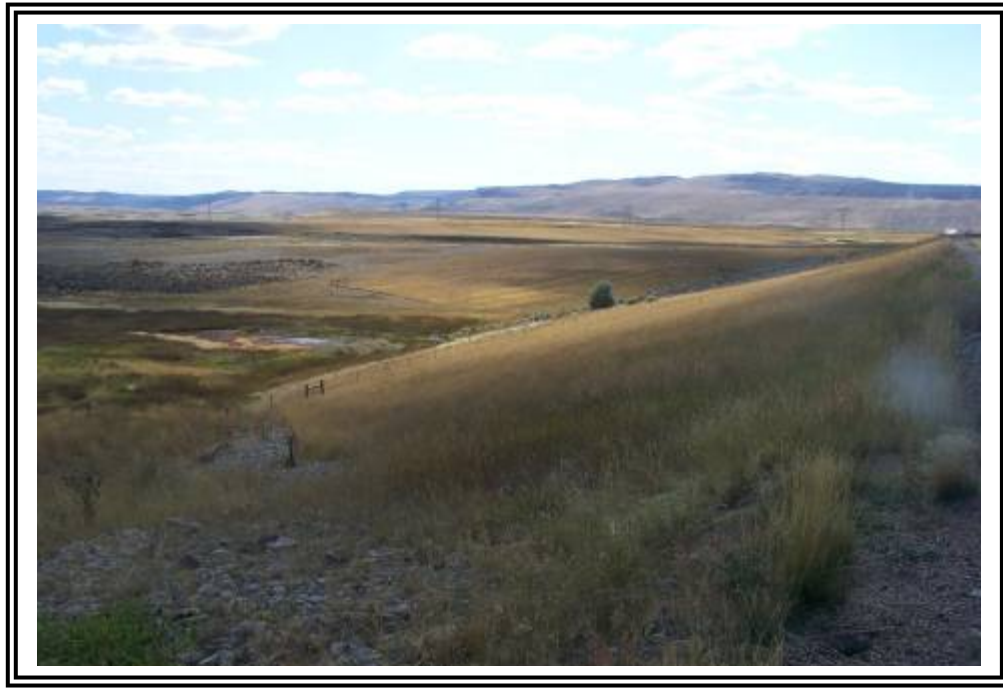
Seepage has been observed and studied in the past in the area of the east groin of the Main Dike. Photo 71 shows the groin with protective rip rap. Studies by Cornforth Consultants suggest that the observed seepage is from groundwater running along near surface bedrock. Sloughing has been observed in the natural ground beyond the Main Dike, but has not impacted the integrity of the Main Dike.

East groin Main Dike.

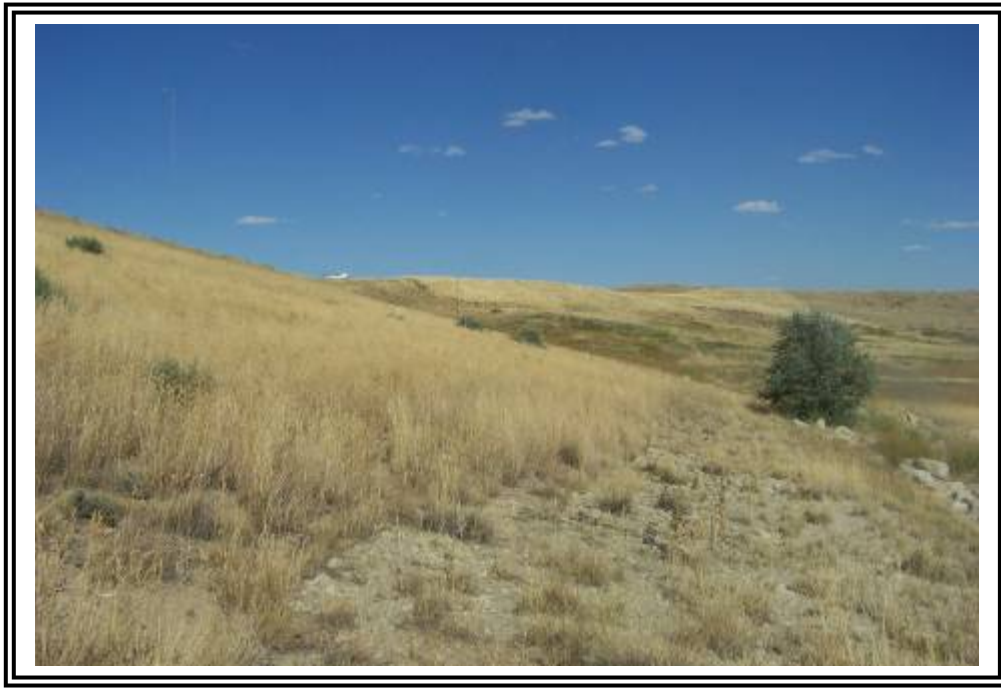
79

Occasional erosion rills, animal burrows, and sage bushes were observed on the downstream slope of the Main Dike. These types of features are shown in Photos 73, 79, and 82. The downstream toe contains a blanket drain that daylights at the toe. This lower area of the embankment is protected with small rip rap.

Downstream slope of Main Dike. Sage bushes to be removed.

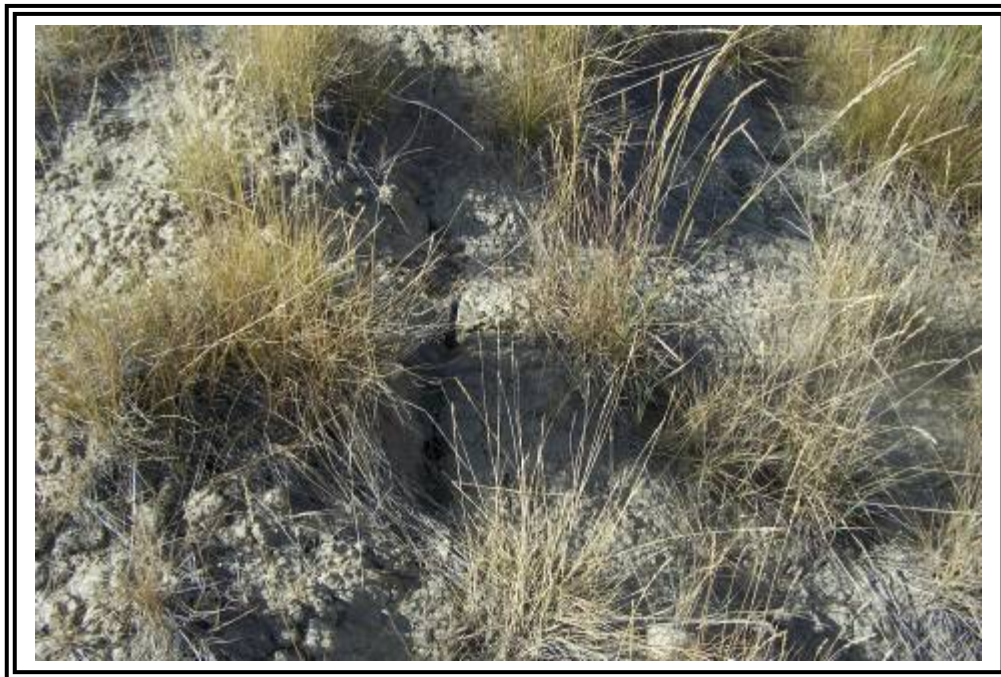
The East Saddle Dike does not fully impound water but provides freeboard storage. The upstream slope of the East Saddle Dike is covered with rip rap as shown in Photos 84 and 90. The crest and downstream slope are covered in crested wheatgrass as shown in Photos 85 and 88. An intermittent, but somewhat continuous, linear crack was observed at the crest/downstream slope intersection as shown in Photos 86 and 87.

Crack at crest/downstream slope of break. Crack appeared intermittently along the length of the East Saddle Dike.

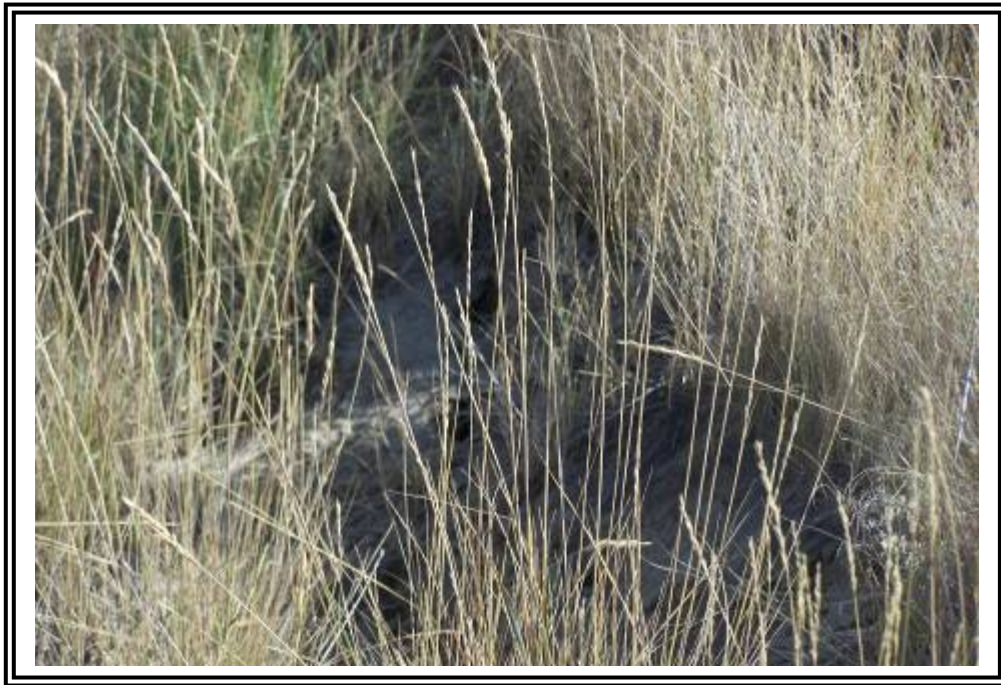
87

Crack at crest/downstream slope of break. Crack appeared intermittently along the length of the East Saddle Dike.

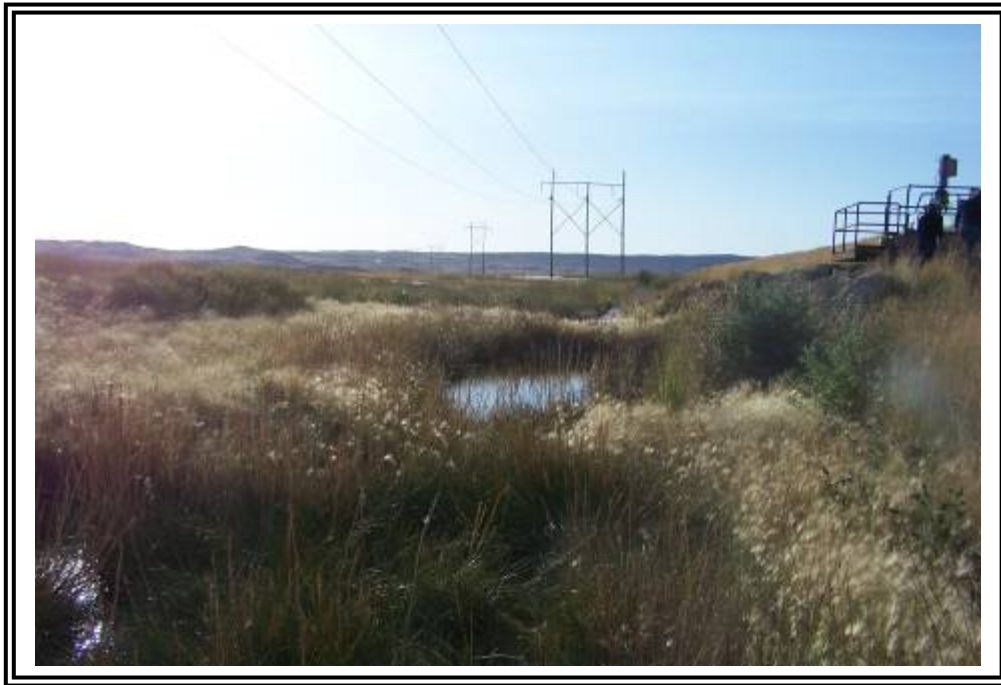
Standing water was observed “upstream” of the discharge structure as shown in Photo 95 and 100. Plant personnel indicated that this is likely water that accumulates when the outlet is flowing at a higher volume than it was on the day of our site visit, and then because of the grading along the toe, the water ponds in this area. CHA did not observe signs that this standing water would be seepage, and the water was clear.

Standing water at toe of northeast dike “upstream” of discharge channel.

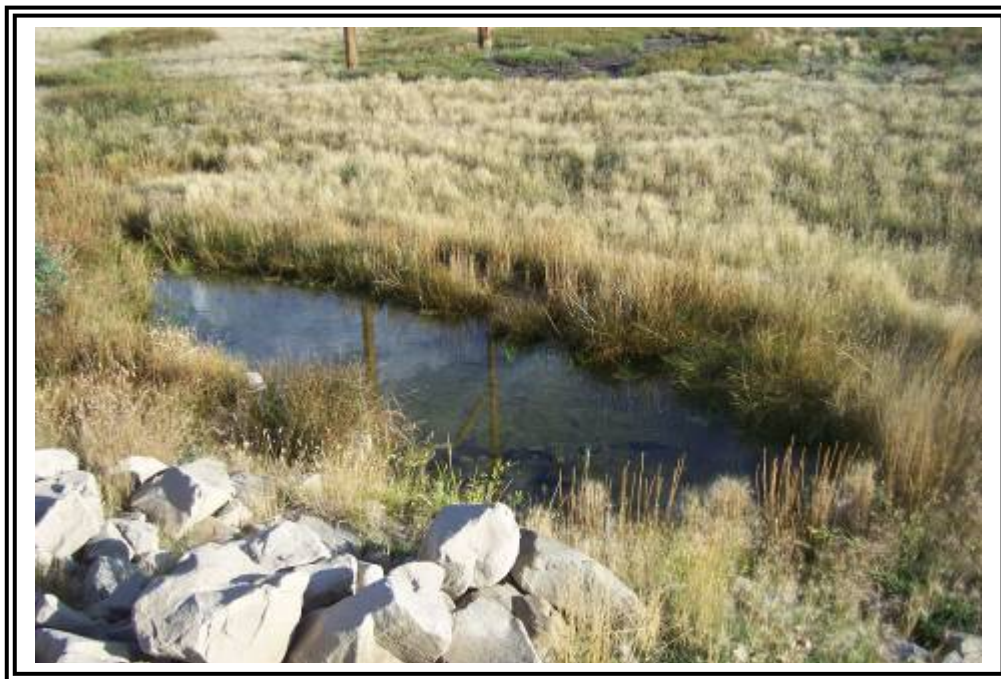
100

Standing water “upstream” of discharge channel. Plant personnel indicated outflow from pond sometimes higher than during CHA site visit that may back-up into this area. No flow in water observed by CHA.

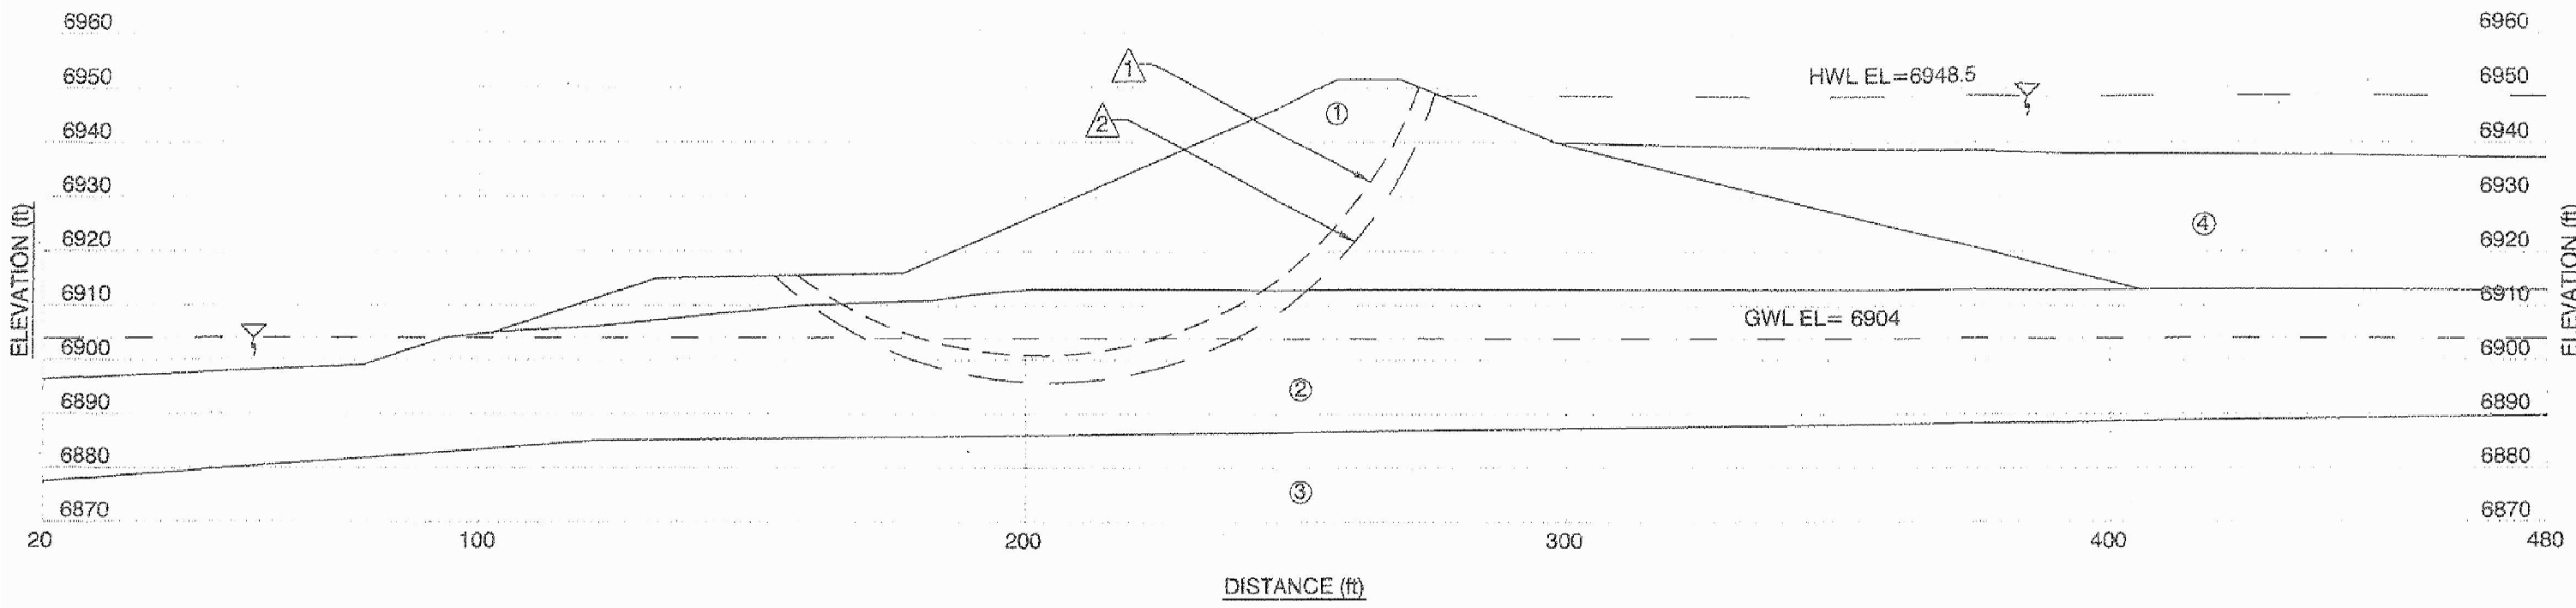
SOIL LAYER	WET UNIT WEIGHT (pcf)	COHESION (pcf)	FRICTION ANGLE (°)
① FILL	122.0	600	26
② LEAN CLAY	119.5	200	25
③ CLAYSTONE	130.2	4000	0
④ SOLIDS	80.0	0	0

CASE	①	②
CONDITIONS	STATIC	PSEUDO-STATIC
MINIMUM FACTOR OF SAFETY	2.02	1.56
REQUIRED FACTOR OF SAFETY	1.5	1.0
SEISMIC COEFFICIENT	0.00 g	0.10 g
